**Aerodynamic Impact of Leading Edge Surface Treatments
on Wind Turbine Blades**

Nathan A. Kidder

April 2015

Presented in Partial Fulfillment of the Requirements for Graduation with Honors Research
Distinction in Aeronautical and Astronautical Engineering at The Ohio State University

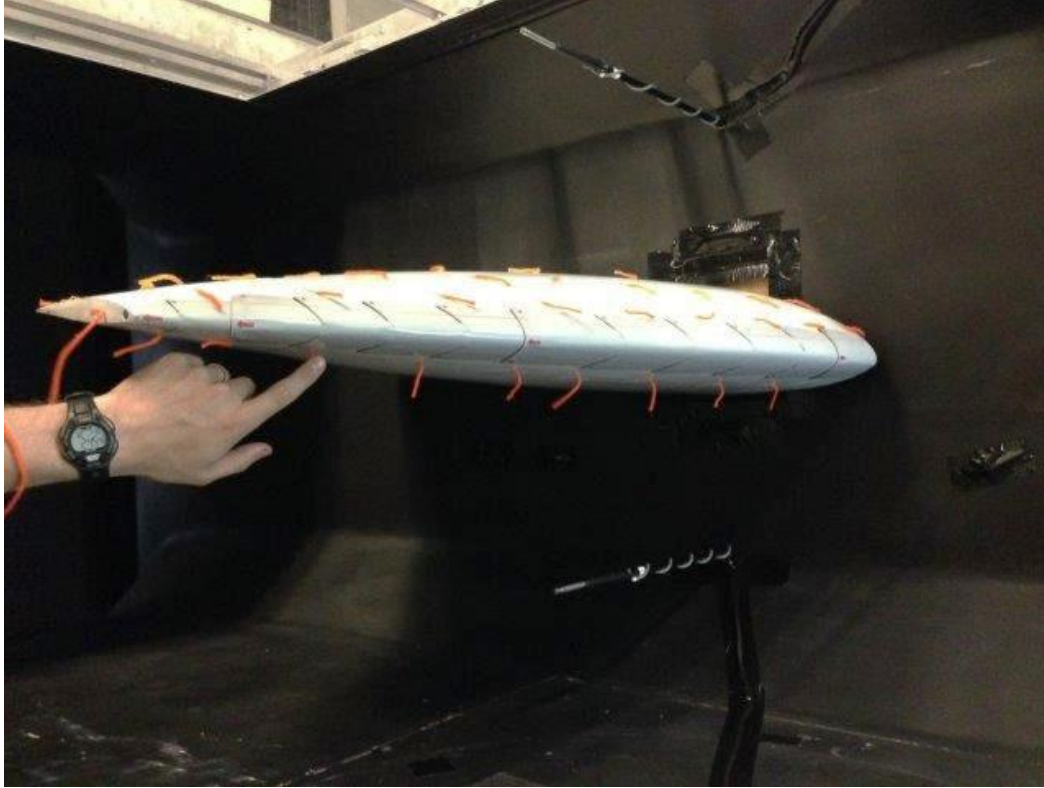
Figure 14: Tip Section with Treatment and Tufts

The tip section was first investigated to determine the angle of attack at which stall occurred. This was performed by installing yarn tufts across the suction surface of the section. Separation was seen to occur slightly aft of the leading edge. The stall angle was twenty degrees for the baseline and 21.5 degrees with the treatment applied. An image of the tip section with attached tufts and treatment applied is included below as Figure 14. The upstream microphones are also visible in the image.
